# EXECUTIVE SUMMARY

## I-69, I-66/I-65 Spurs, and US 60 Connection Strategic Planning Corridor Study

### Overview of Existing Conditions

### William H. Natcher Parkway, Audubon Parkway, and US 60 Wendell Ford Expressway

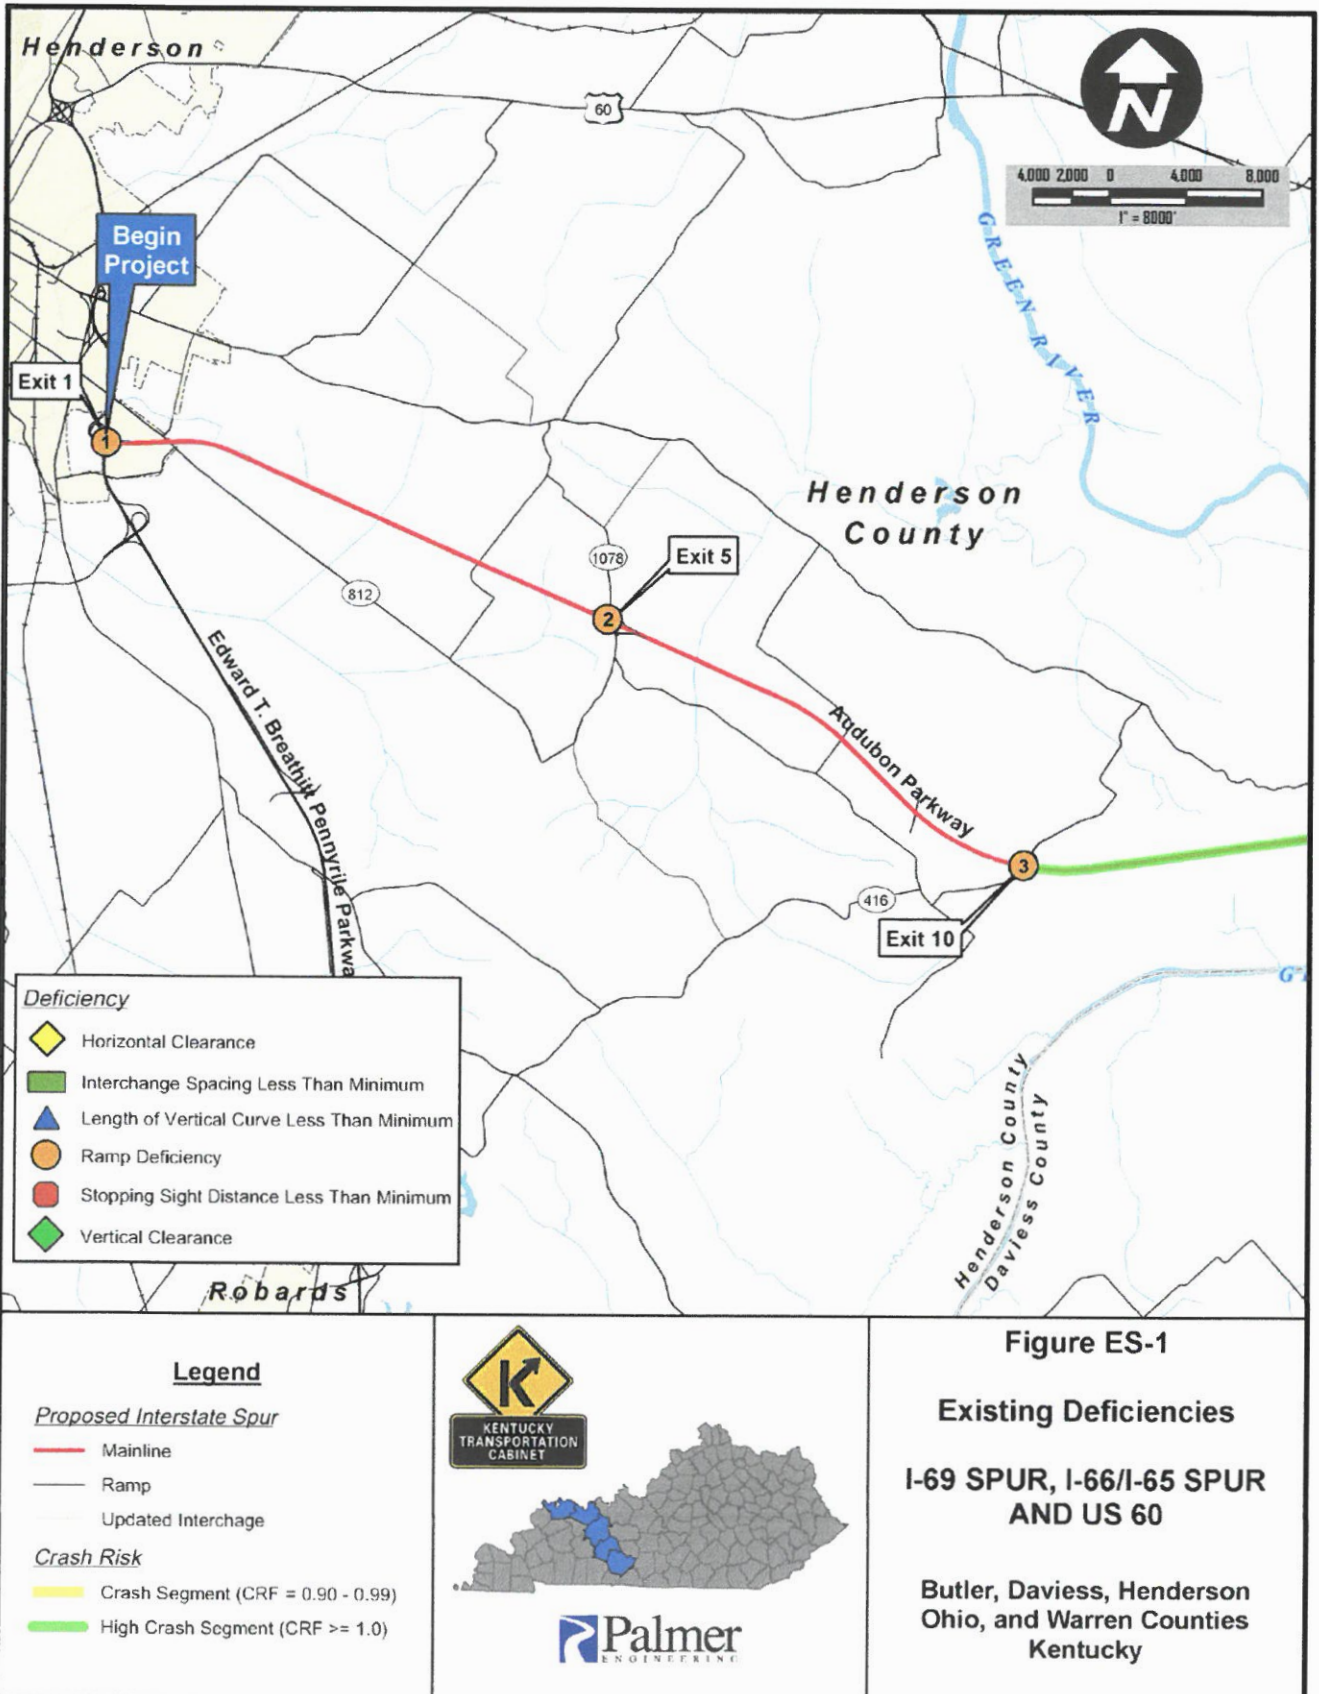
**Figure ES-2**

**Legend**

*Crash Risk*

- Crash Segment (CRF = 0.90 - 0.99)
- High Crash Segment (CRF >= 1.0)

**Existing Deficiencies**

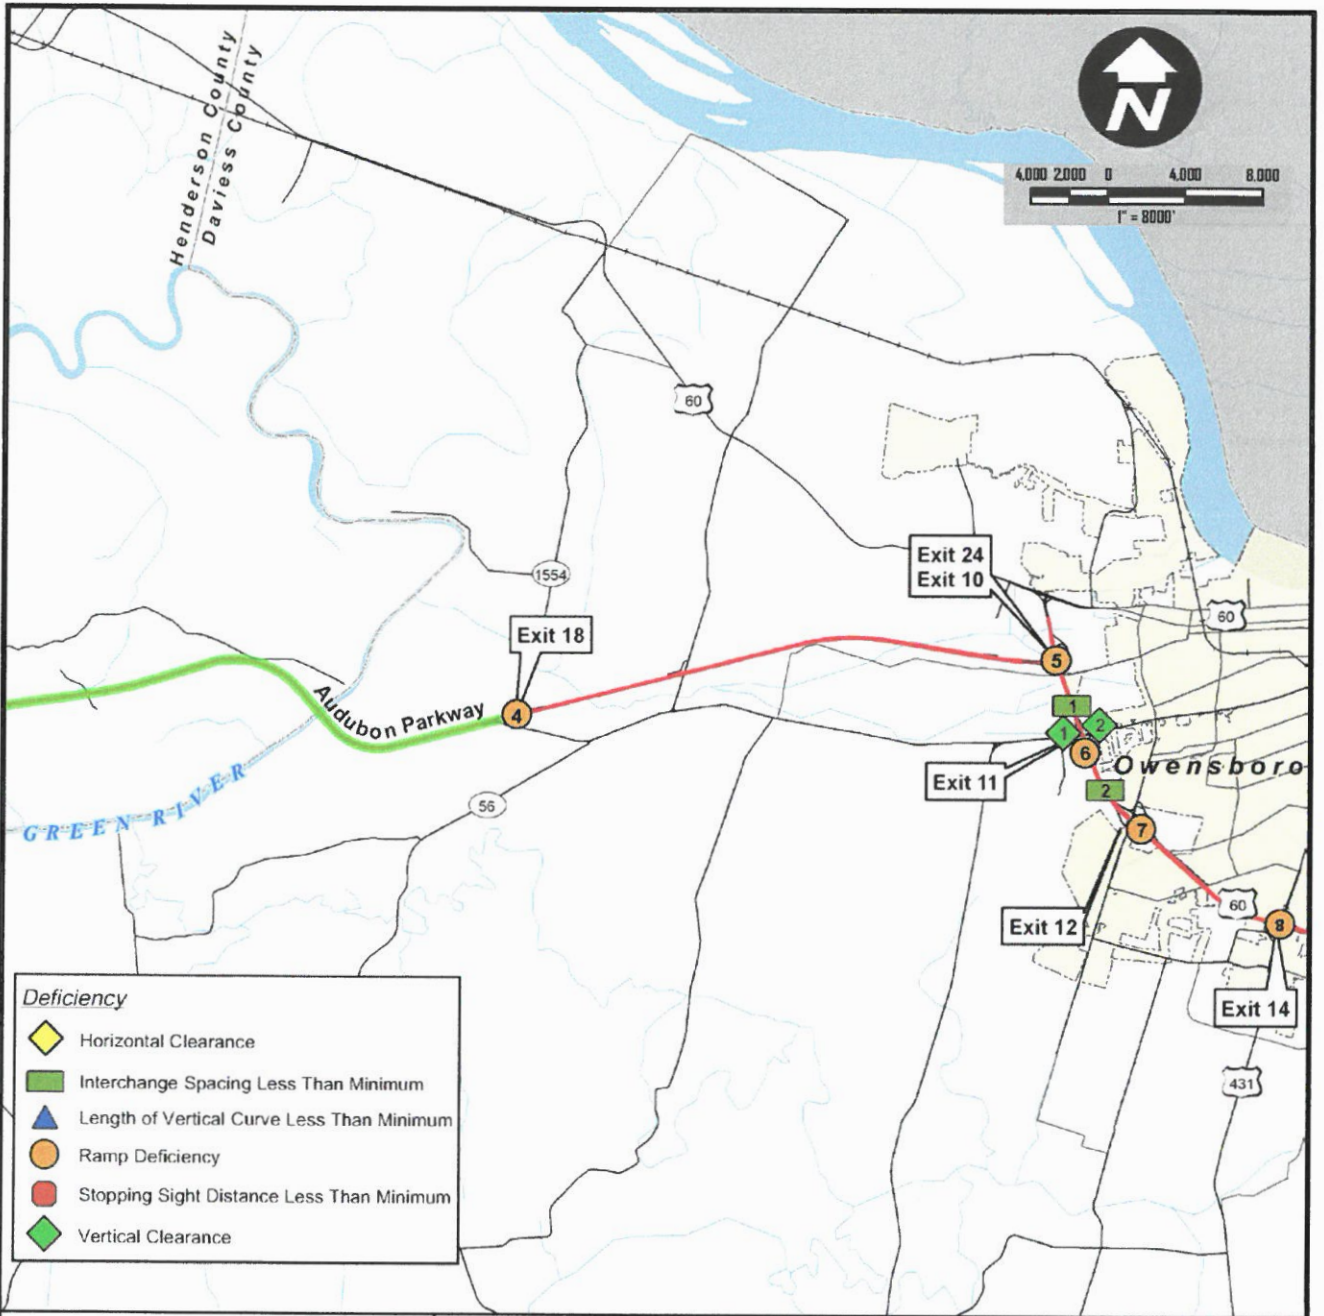
- Crash Analysis – Audubon Parkway: Compared to other Kentucky parkways, one segment in Henderson/Daviess County (MP 10.141 – 18.049) has a critical crash rate between 0.9 and 0.99.

- Crash Analysis – Audubon Parkway as an Interstate: Compared to Kentucky interstates, rather than state parkways, one high crash segment was identified along the Audubon Parkway located in Henderson/Daviess County (MP 10.141 – MP 18.049). The segment has a critical crash rate factor of 1.13.

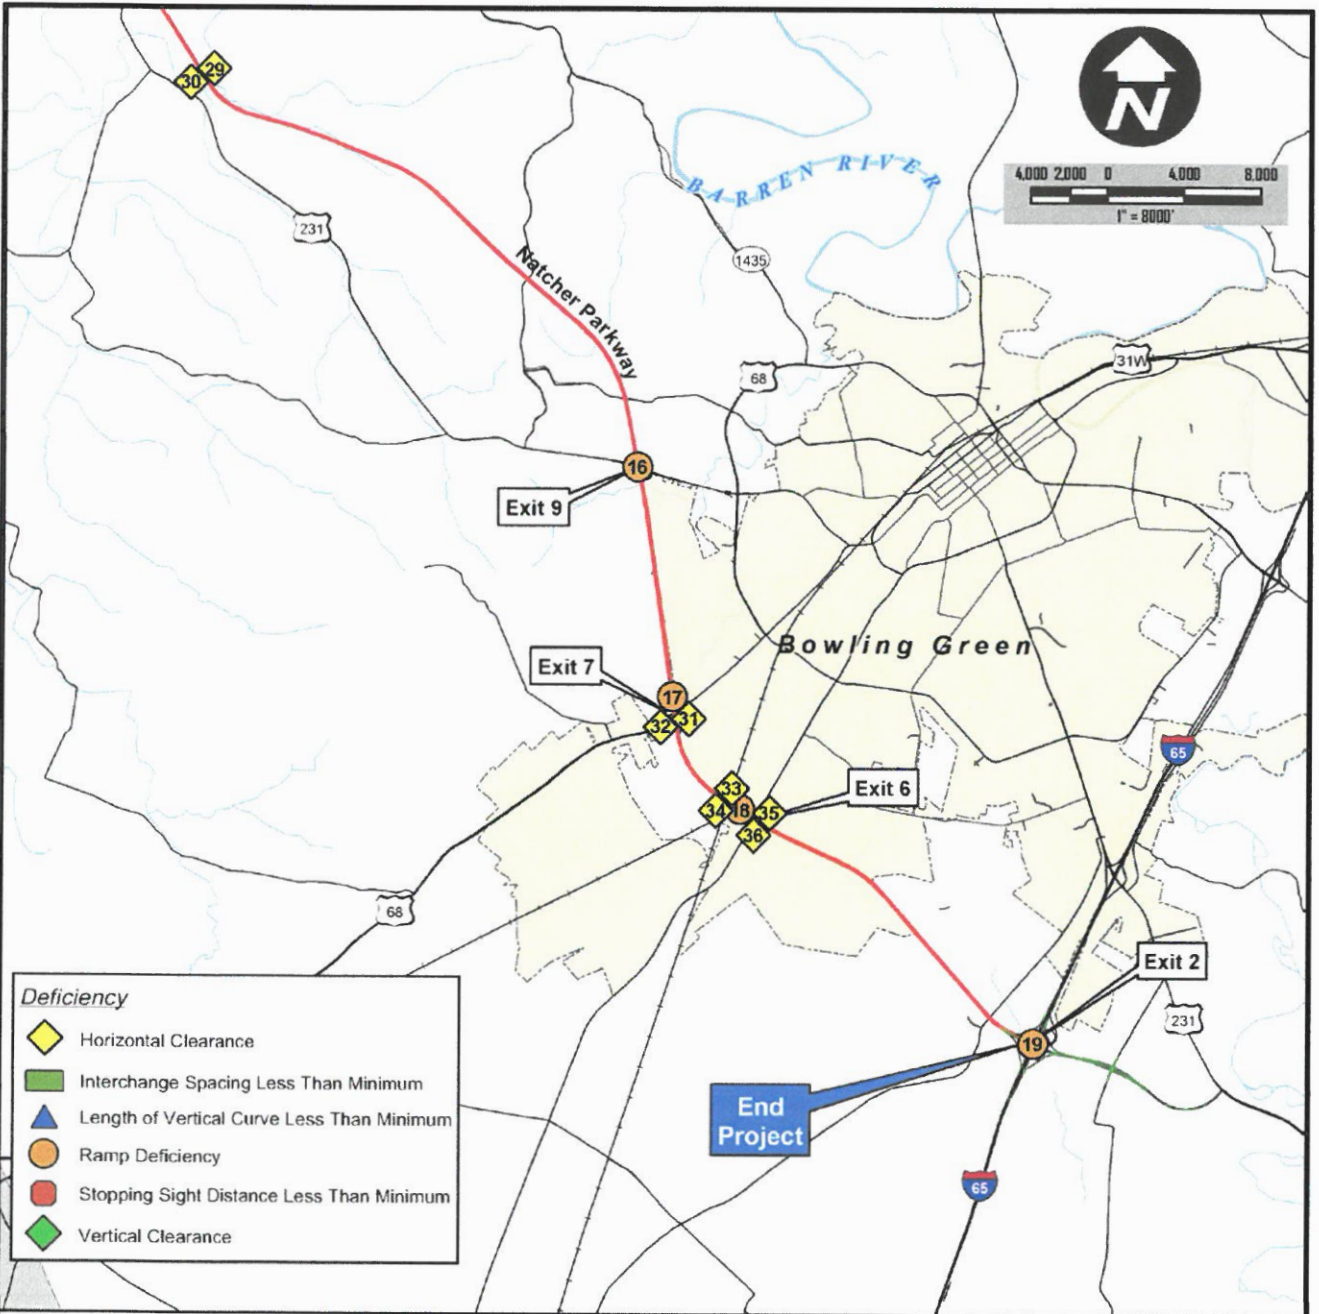
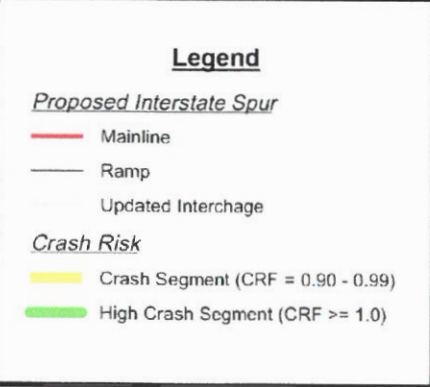
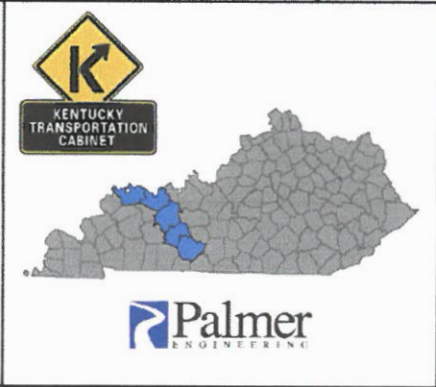
**Figure ES-7**

**Existing Deficiencies**

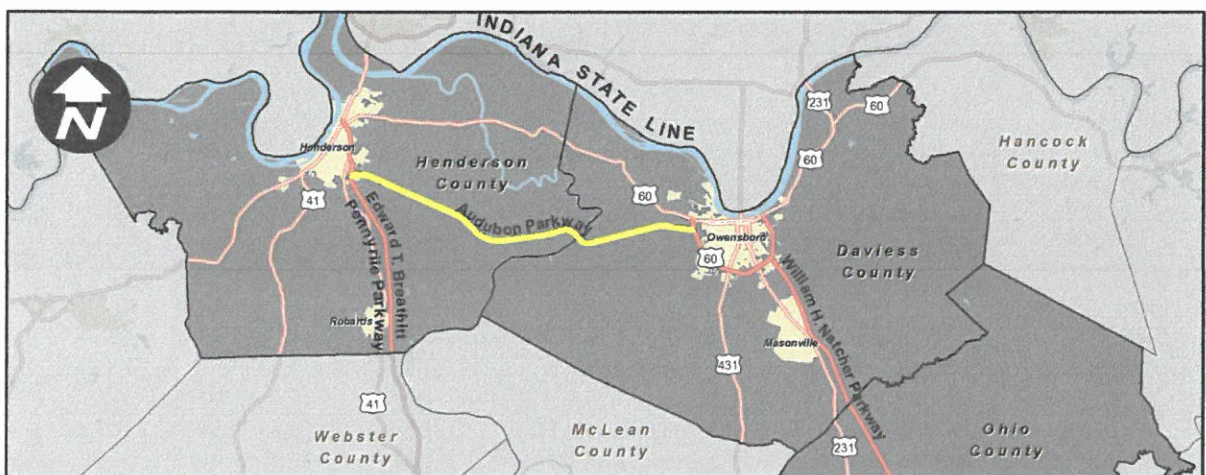
### • Option 1 - I-69 Spur

This option designates the I-69 Spur to follow along the Audubon Parkway from Henderson to the US 60 interchange in Owensboro. The interstate spur would begin at I-69 south of Henderson and would terminate at the US 60 interchange in Owensboro. At the time of this report, the I-69 alignment through Henderson is under evaluation, and the intersecting location with the Audubon Parkway is undetermined. The Audubon Parkway cannot be designated as an interstate spur until it connects with a route that has been designated as I-69.

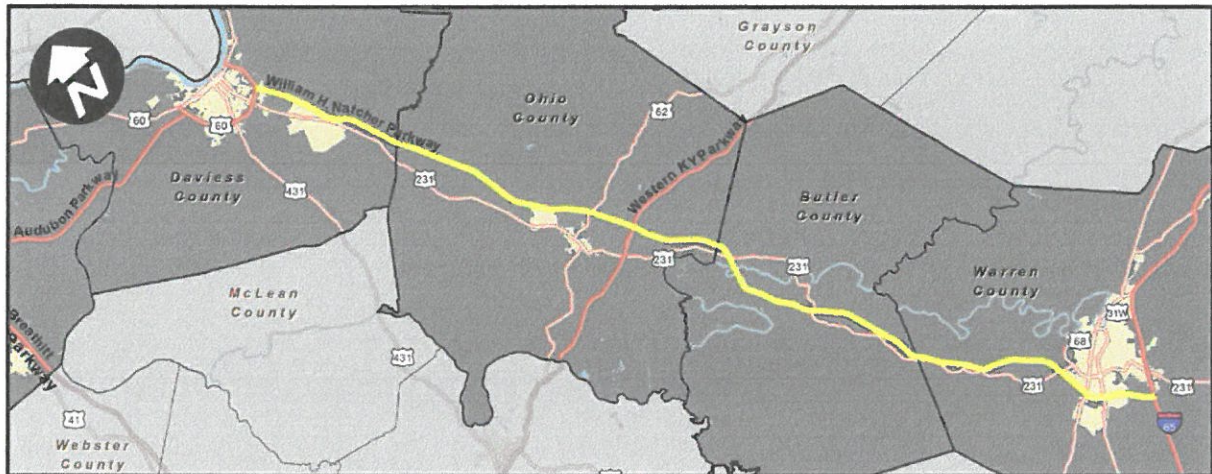
- **Option 2 - I-66/I-65 Spur**

This option designates the I-66/I-65 Spur along the Natcher Parkway from I-65 in Bowling Green to the US 60 interchange in Owensboro. The I-66/I-65 Spur would begin at the existing I-65 and Natcher Parkway interchange and terminate at the existing Natcher Parkway and US 60 interchange at the east side of Owensboro.

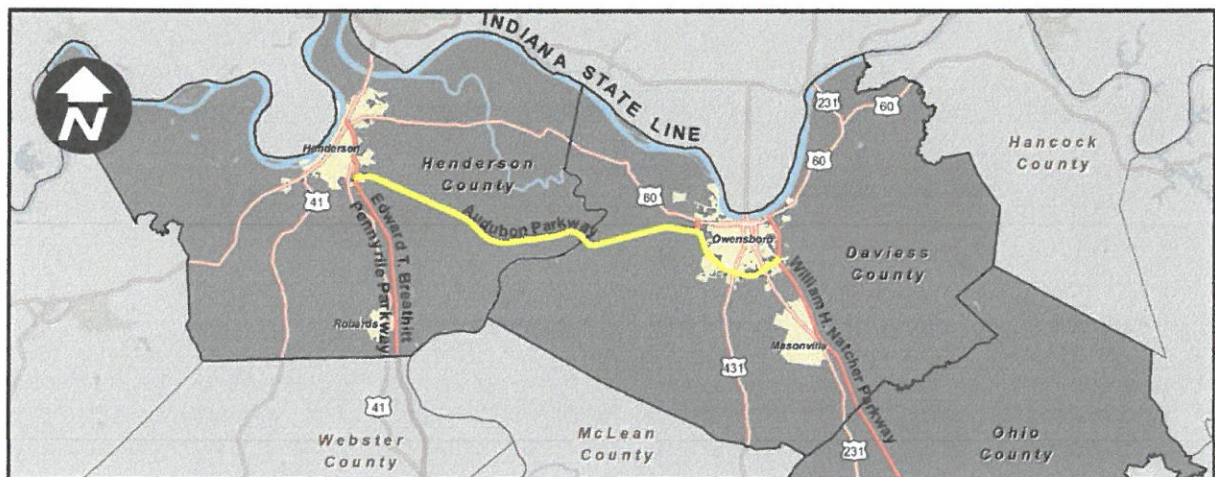
- **Option 3 - I-69 Spur including US 60**

The third option designates the Audubon Parkway and US 60 as I-69 Spur. Similar to Option 1, the I-69 Spur would follow along the Audubon Parkway from south of Henderson to the US 60 interchange in Owensboro. The spur would continue along US 60 and terminate at the US 60 and Natcher Parkway interchange on the east side of Owensboro. At the time of this report, the I-69 alignment through Henderson is under evaluation, and the intersecting location with the Audubon Parkway is undetermined. The Audubon Parkway and US 60 cannot be designated as an interstate spur until the Audubon Parkway connects with a route that has been designated as I-69.

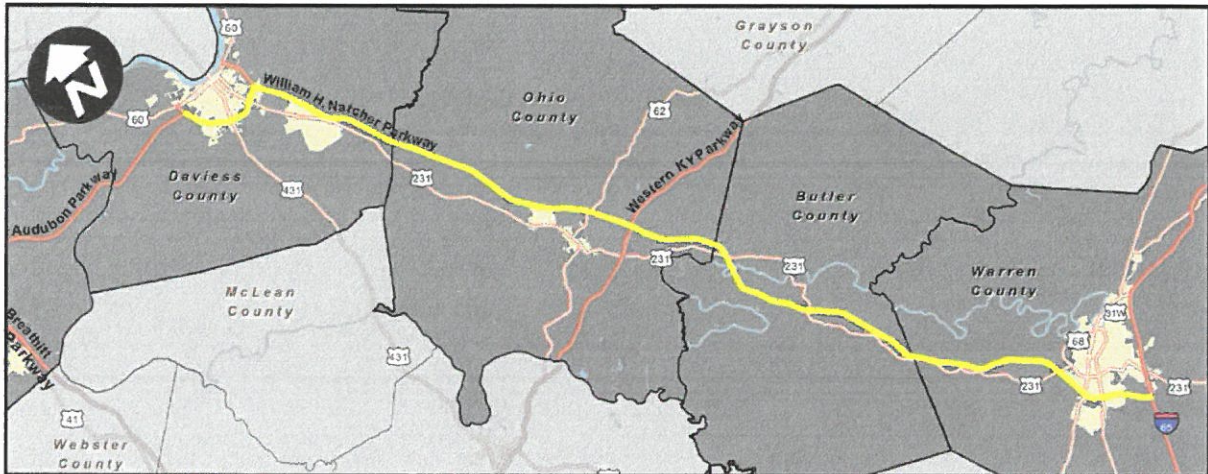
- **Option 4 - I-66/I-65 Spur including US 60**

This option designates the Natcher Parkway and US 60 as I-66/I-65 Spur. Similar to Option 2, the I-66/I-65 spur would follow along the Natcher Parkway from I-65 in Bowling Green to the US 60 interchange in Owensboro. The spur would continue on US 60 and terminate at the US 60 and Audubon Parkway interchange on the west side of Owensboro.
